Seismic Retrofit

Strengthening Tilt-Up Structures

By David L. McCormick

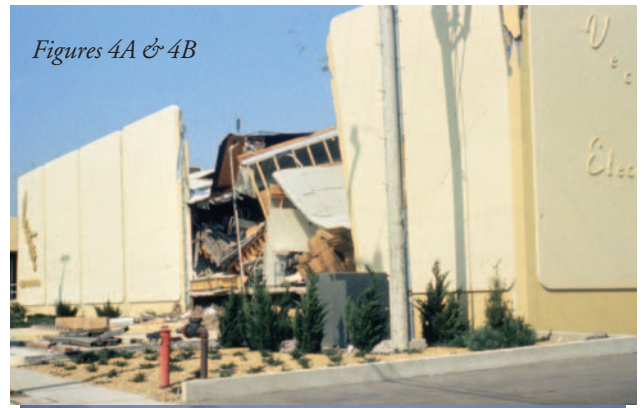
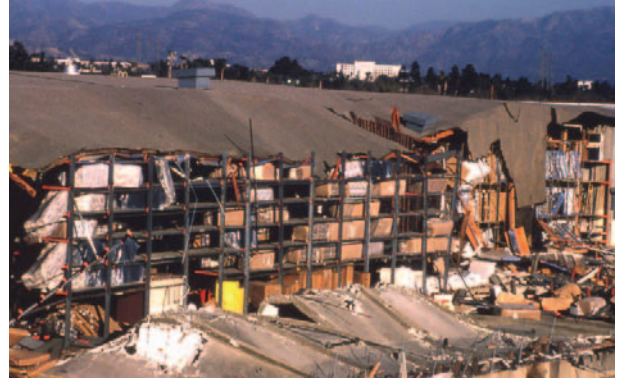
Figures 4A & 4B

Collapsed Tilt-Ups.

Prior to the 1971 San Fernando earthquake, the connections between the concrete walls and the wood roof were typically not engineered. The plywood roof was nailed to 3-inch or 4-inch thick wood members called *ledgers*, which were in turn, bolted to the *wall panels* (Figure 2). When an earthquake occurs, forces perpendicular to the walls must be resisted at the base and the top of the walls (Figure 3). In the San Fernando earthquake, it was demonstrated that the connection in Figure 2 was too weak to provide support at the top of the walls, and the walls and roof separated, leading to building collapses (Figure 4).
